LEICESTERSHIRE

FIRE and RESCUE SERVICE

Building Name: ASHBY

Building Address: Wilfred Place, Ashby-De-La-Zouch, LE65 2GW

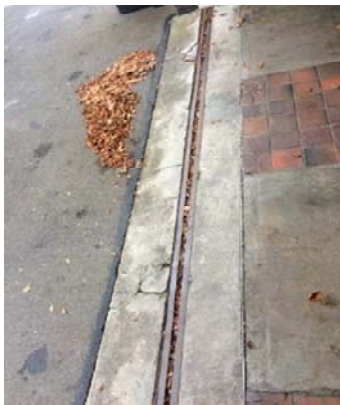
Photo 1 - Cracked concrete ramp

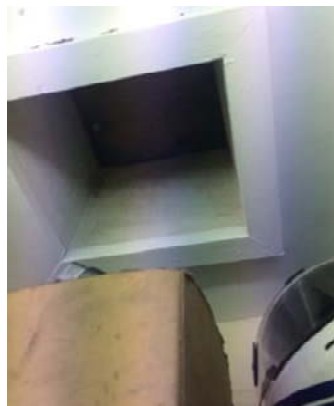
Photo 2 - Water stained old roof light box

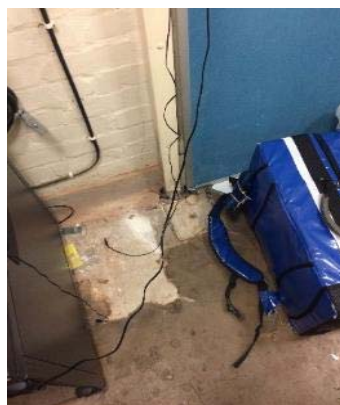
Element	Description	Condition	Condition Grade	Priority Rating	Action	Predicted Expenditure Year & Cost (£)			
						Year 1 (urgent)	Year 1 & 2	Year 3 to 5	Year 6 to 10
Floor	Concrete with old hessian lined resin flooring	Life expired	4	3	Replace with vinyl flooring		260		
Floor	Concrete sub-floor	Penetration adjacent to access panel and electrical conduit	3	4	Infill with sand cement mortar mix		50		
Doors	Oak laminate fd30 fire door with vision panel		2						
Joinery	Painted timber architrave and door lining		2						
Ladies WC									
Ceiling	Painted plaster		2						
Walls	Painted brickwork		2						
Floor	Original quarry tiling with tiled upstand	Stained quarry tiles	2	4	Deep clean tiles, consider removing upstand and over laying year 6-10		25		280
Doors	Oak laminate solid core doors		2						
Joinery	Painted timber architrave and door lining		2						
Sanitary ware	New WC and wash hand basin		1

Photo 3 - Life expired flooring

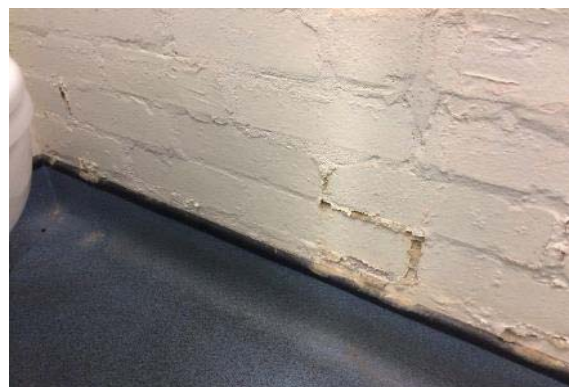
Photo 4 - Penetrating damp

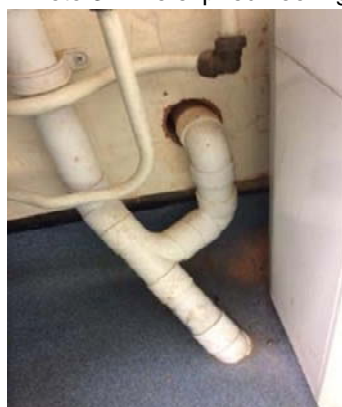
Photo 5 - Poor finish to plumbing

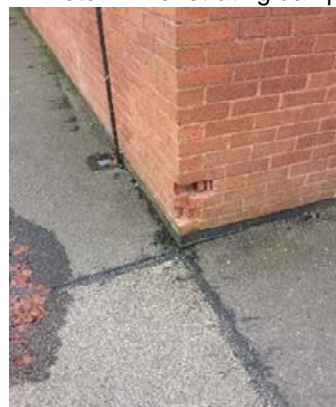
Photo 6 - Damaged brickwork

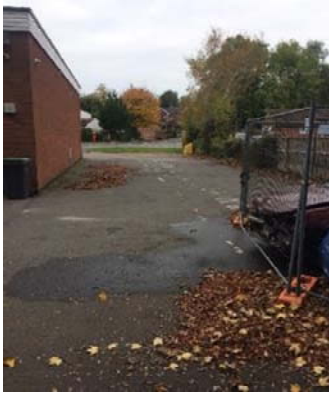
Photo 7 - Poor line marking

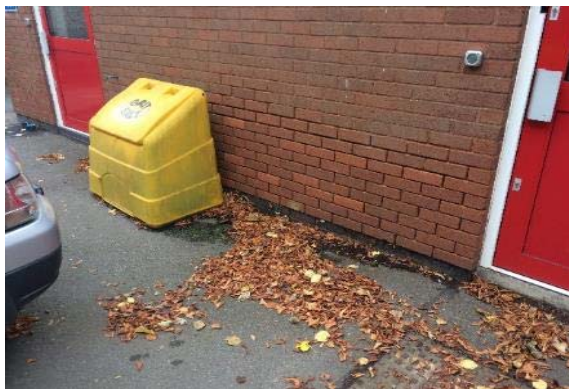
Photo 9 - Loose/Friable mortar
